## The Archaeology of Brack Mount: details of an exciting archaeological discovery on the summit of one of Lewes's most prominent landmarks

### The current investigation

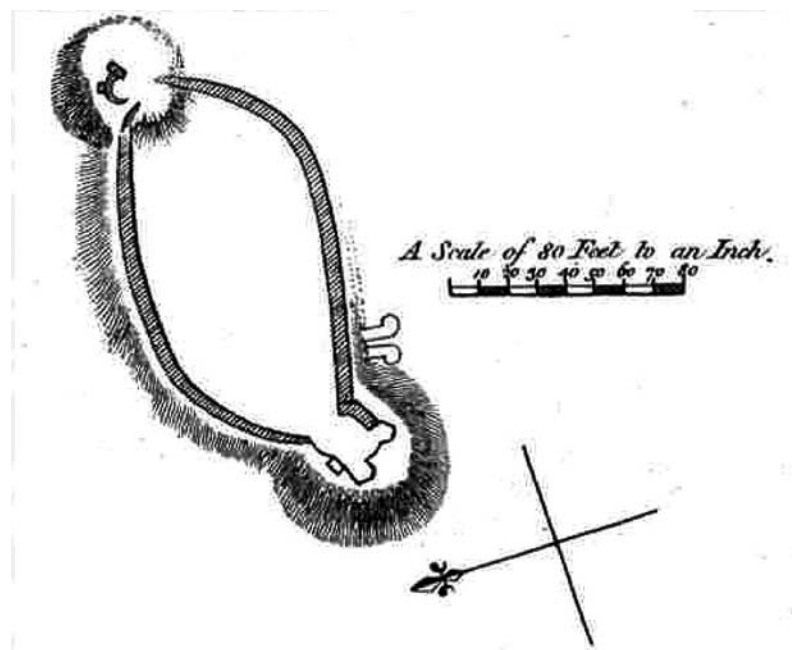
Extract from Green's plan showing surviving castle defences; Brack Mount is on the upper left

The standing defences were already in a ruinous state of repair when the Mount was first recorded in historical sources, although such descriptions and images provide a flavour of their original nature and scale. The earliest known source of about 1533 records the removal by townspeople of timber from its summit (Poole 1997, 7). Two maps of 1620 clearly portray the castle with complete circuits of walls on both mottes (Farrant 1996, 169, note 4) and William Green's 1776 plan of the castle published within Grose's *Antiquities of England and Wales* depicts a masonry structure with a north-facing semi-circular angle tower or bastion. A threedimensional view of a 20ft-section of these masonry defences is also illustrated in a James Lambert watercolour of 1772 (Farrant 1996, note 14 with references). A surviving section of wall on the SE side of the mount below the summit may represent the vestiges of these illustrated features (see fig above).

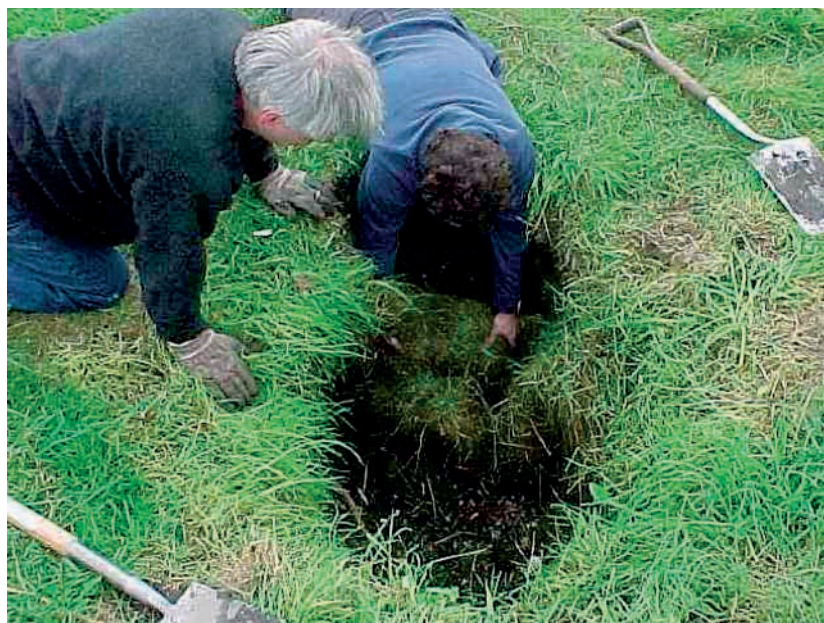
*Removing the overhanging turf at the entrance to the subsided void*

The Sussex Archaeological Society were first informed of subsidence on the summit of Brack Mount by the present owner of Brack Mount House, Andy Gammon, in April 2001. Following a visit by English Heritage Inspector and the County Archaeologist, it was agreed that limited work could be undertaken under Class 5 Scheduled Monument Consent so that the extent of the void could be ascertained prior to its infilling.

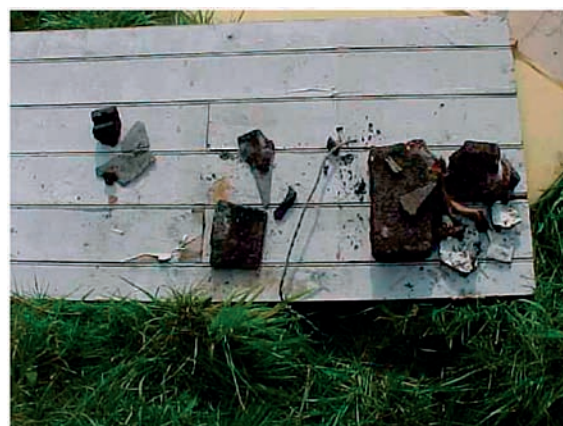
*Fragments of demolition material and a toilet bowl.*

Removal of the upper layer of slumped topsoil revealed a dumped deposit of demolition material and rubbish containing brick, tile and several fragments of a ceramic toilet bowl. Artefacts from this deposit indicated that it was probably the backfill of Thompson's earlier investigation of 1962. Moreover, the fragments of toilet basin suggest that Thompson may have used as backfill the demolished remains of an outside toilet dating from the Mount's use as a pub garden, an attribution which explains the potential function of one of the two uninhabited structures recorded on early edition OS maps.

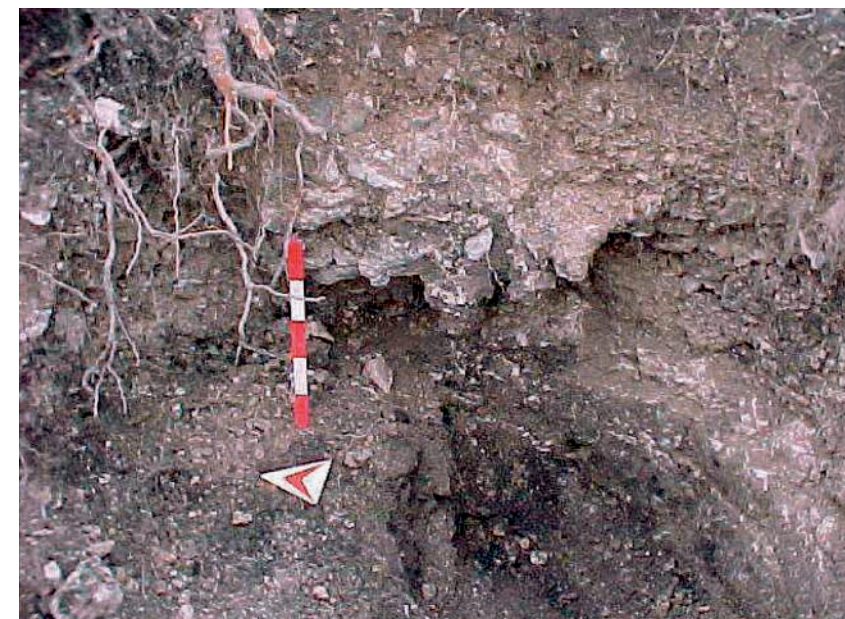
*View of mortared section of flint walling or foundation in west-facing section with well steining exposed below on the right*

The sides of the void below the depth of the topsoil were composed of a very loose gravel deposit also containing flint nodules, some of which were mortared, and in the west-facing section, a substantial overhanging section of mortared flint walling or foundation. A stub of this was also seen in the east-facing section.

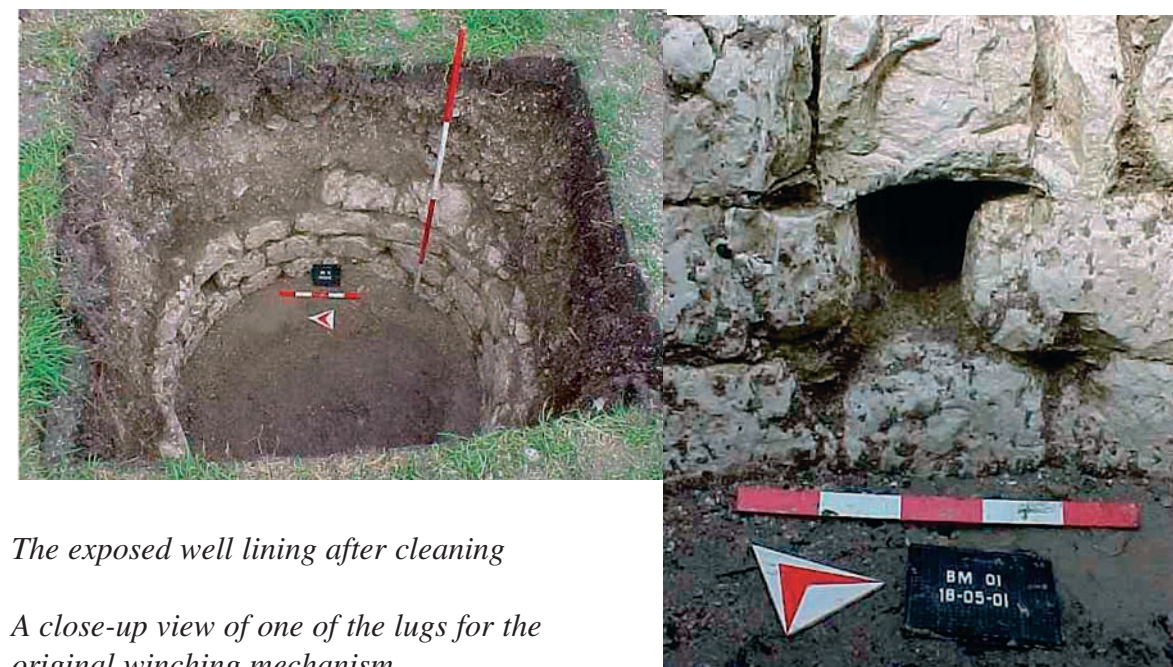
*The exposed well lining after cleaning*

After further removal of the dumped deposit the cause of the mystery subsidence finally revealed itself to be a circular well, 1.8m in diameter, constructed of chalk ashlar blocks set within thin spreads of mortar. The well lining or 'steining', which was sealed below the overlying gravel deposit, was very carefully constructed in regular courses to produce a curved, vertical, inner surface; several of the blocks displayed tooling marks.

By the time all of the 1962 backfill was removed the well had been exposed to a depth of three and a bit courses. Cleaning revealed a difference between the lower and uppermost courses; whereas the former were vertical, the chalk blocks comprising the latter were angled to create a slanting lip indicating that the well had survived to its original height. Also revealed were two pairs of sub-rectangular recesses associated with the original wooden winching mechanism.

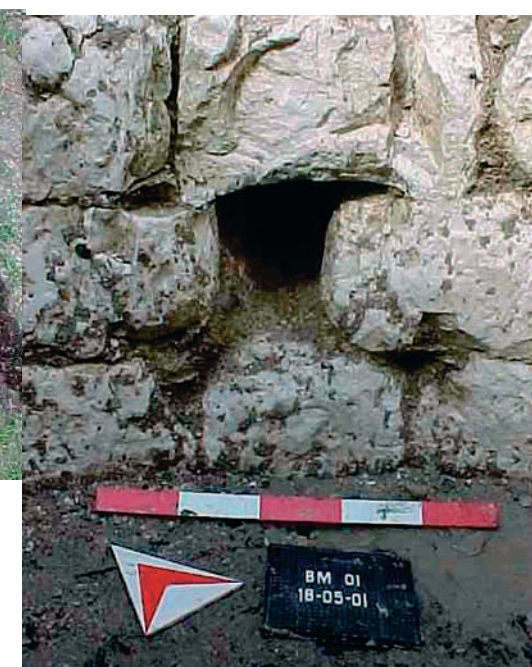
*A close-up view of one of the lugs for the original winching mechanism*
